Economizer Inlet Header Cracking

Advise owners and operators to inspect economizer inlet headers. Several recent inspections have revealed cracking on the inside diameters of tube stubs and header bore holes.

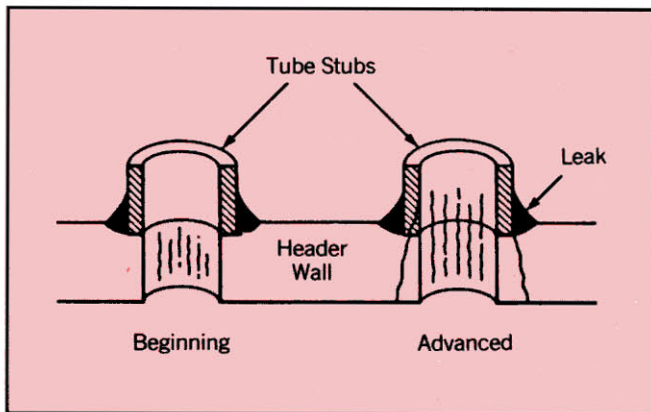
Figure 1 Economizer header cracking.

The economizer inlet header on any drum type unit may be subjected to thermal quenching during start-ups and hot banked conditions. The thermal fatigue is caused primarily by relatively cold feedwater being intermittently added to the unit when the inlet header is hot. The feedwater flow can be infrequent enough so that between flow periods the header temperature rises considerably above that of available feedwater.

Often the earliest damage is cracking of the inlet header in the tube hole closest to the inlet connection. The degree of cracking generally decreases with distance from the water inlet connection. This cracking can be quite advanced before leaking occurs. Figure 1 is a sketch depicting the beginning and advanced stages of bore hole cracking.

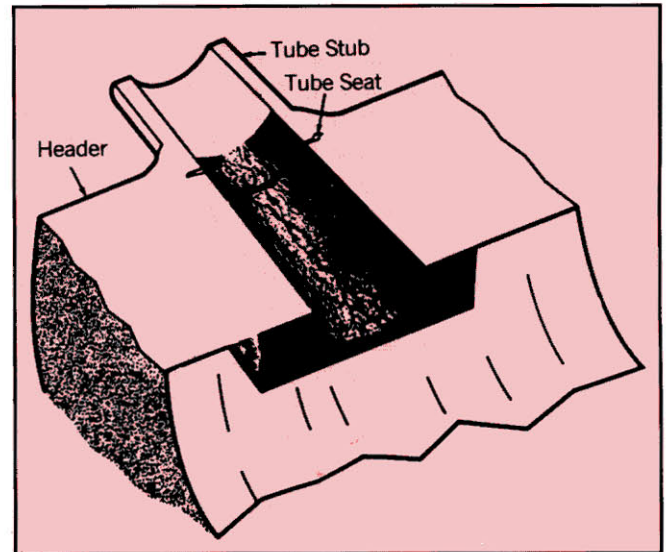
Figure 2 Bore hole cracking.

start-ups, have not shown evidence of header cracking. Figure 2 shows the typical locations of cracking.

Visual internal inspections should be performed on all units that cycle on-off, on all base loaded units that have had a high frequency of forced outages, and on any unit that has experienced economizer inlet header stub leaks. These inspections should be performed using fiber optics.
